# Study Group: Check the necessity to add a Special test to C57.19.00

### Problem:

Partial discharge was detected in OIP bushings during the Low Frequency Test when current flew through the bushing, whereas the same bushings did not show partial discharge in cold condition.

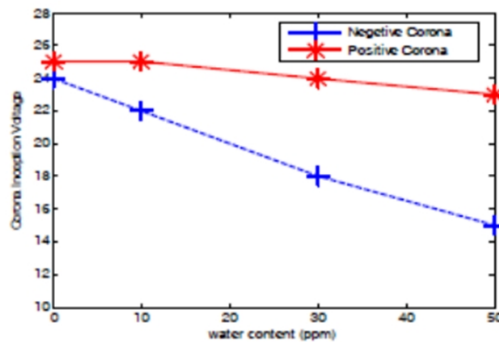
Fig. 15. Positive and negative corona inception voltage as a function of humidity

The influence of the moisture on the PD inception voltage for a needle-plane geometry in oil is analyzed in [2]. The above graph from [2], Figure 15 shows that the negative corona inception voltage is lower for higher moisture in the oil.

The oil of the bushing in which we detected PD was analyzed at a later date. The moisture measured in the oil was 5ppm at around 20°C. As per the Oommen Curves this would correspond to 35ppm moisture in the oil at 55°C in steady state. For 35ppm moisture in the oil, the negative corona inception voltage would have reduced by around 30% based on the curve given above.

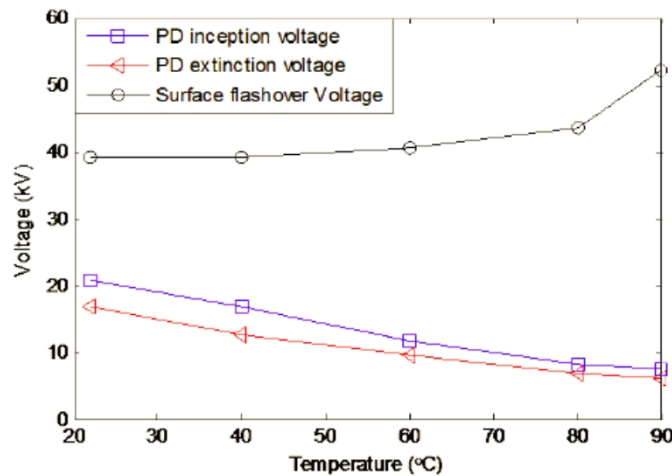
Fig. 3. PD inception, extinction and surface flashover voltage as a function of temperature

The effect of surface discharge on an "oil pressboard interface" is analyzed in [3]. The above graph from [3], Figure 3 shows that the PD inception and extinction voltage for surface discharge is reduced by approximately 50% if the temperature of the oil increases from 20°C to 70°C.
