# ***Case Study:*** **Investigation into Transformer Failure and Positioning of On-Line Moisture Probes**

*Prof. Valery G. Davydov*  
*Consultant*  
*Melbourne, Australia*

**WG PC57.162 Moisture in Insulation Systems**  
F16 IEEE Transformers Committee Meeting  
24 Oct 2016  
Vancouver, BC Canada

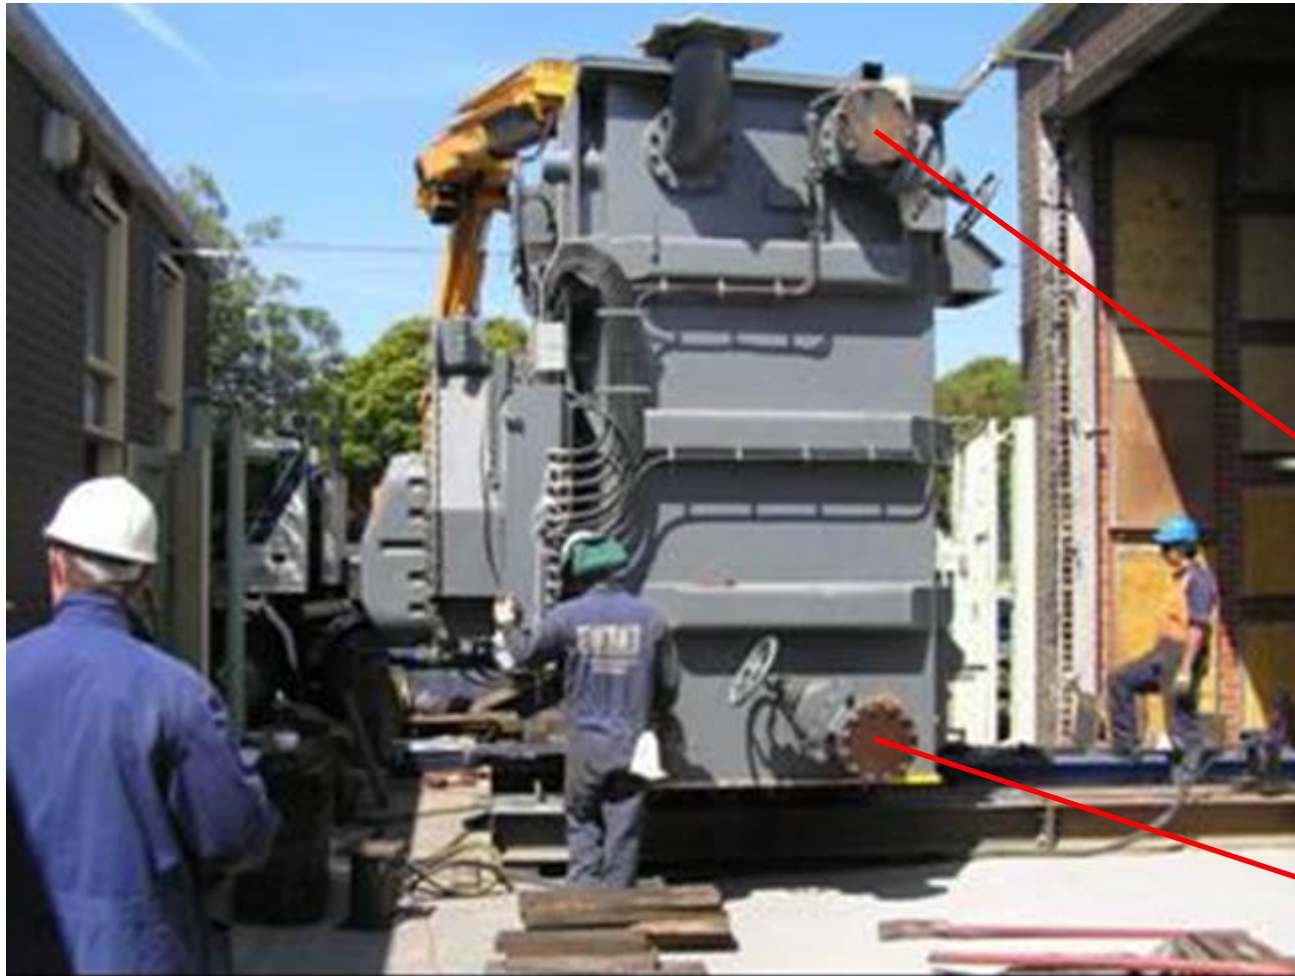
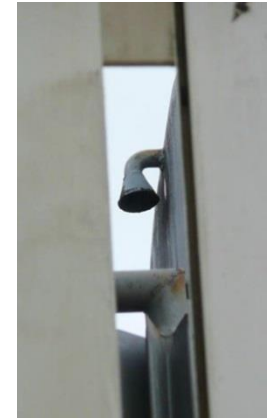
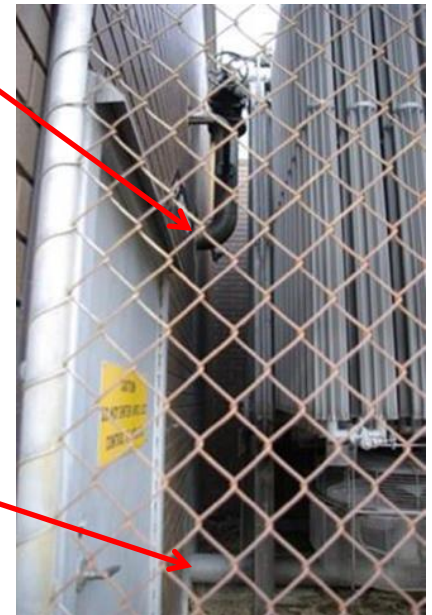
# Zone Substation ONAN Free-Breathing Trf, Australia: Failed on 3 Feb 2005

- It was suggested that the main cause of the failure was foggy (oversaturated) oil around the bottom windings
- Main reasons for the foggy oil formation:
  - Very wet insulation:
    - $WCP_{\text{inner max kf}} = 4.2\%$  (measured using Karl Fischer)
    - $WCP_{\text{surf}} > 5\%$  (estimated for the wettest portion of trf)
  - High amount of water in the oil during a few hot summer days
  - A sudden change of the ambient conditions due to a stormy weather one day before the failure:
    - Rapidly decreasing ambient air temperature, dropping from 36 to 9 °C within 12 hours
    - Heavy cold rain
  - Rapid cooling of oil inside the cooler resulting in the foggy oil

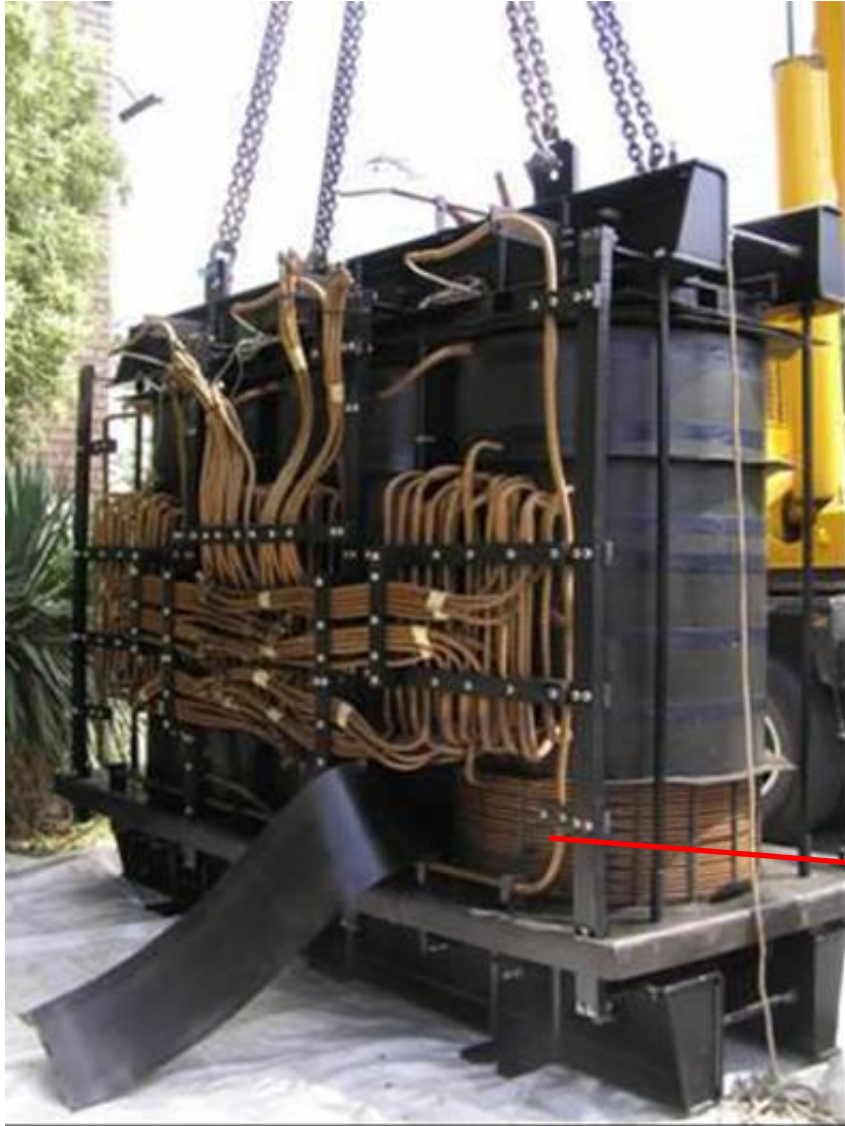
# Damaged HV Section (2005)

- **Condensation of water from oversaturated oil onto the insulation surface of bottom windings**
- **Inception of a corona discharge on the wet surface**
- **Escalation of the corona discharge into a disc-to-disc arcing discharge**

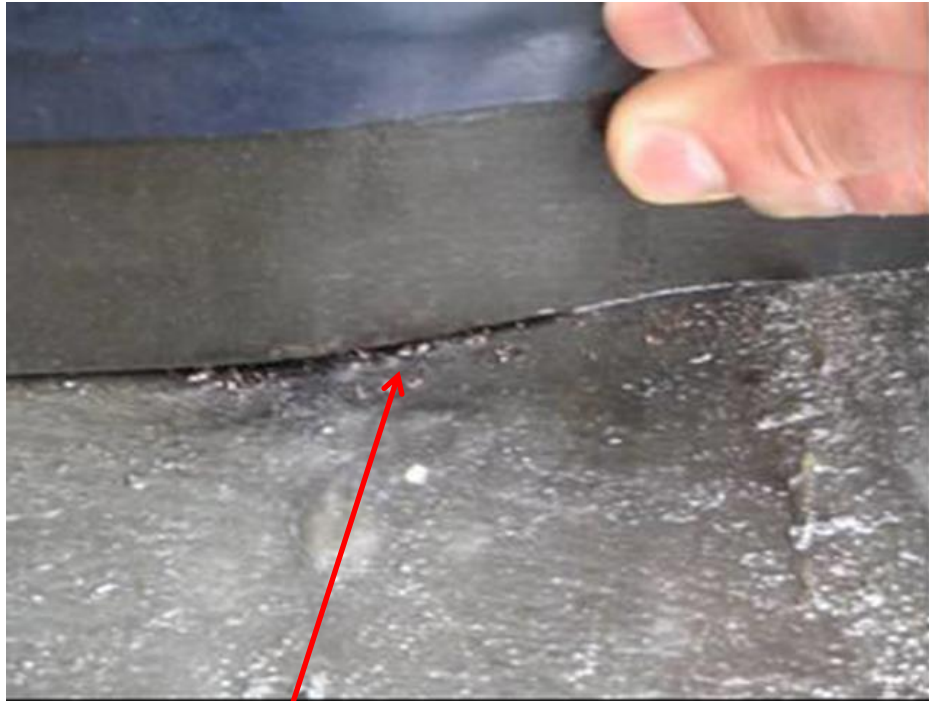
**Melted Copper Balls**

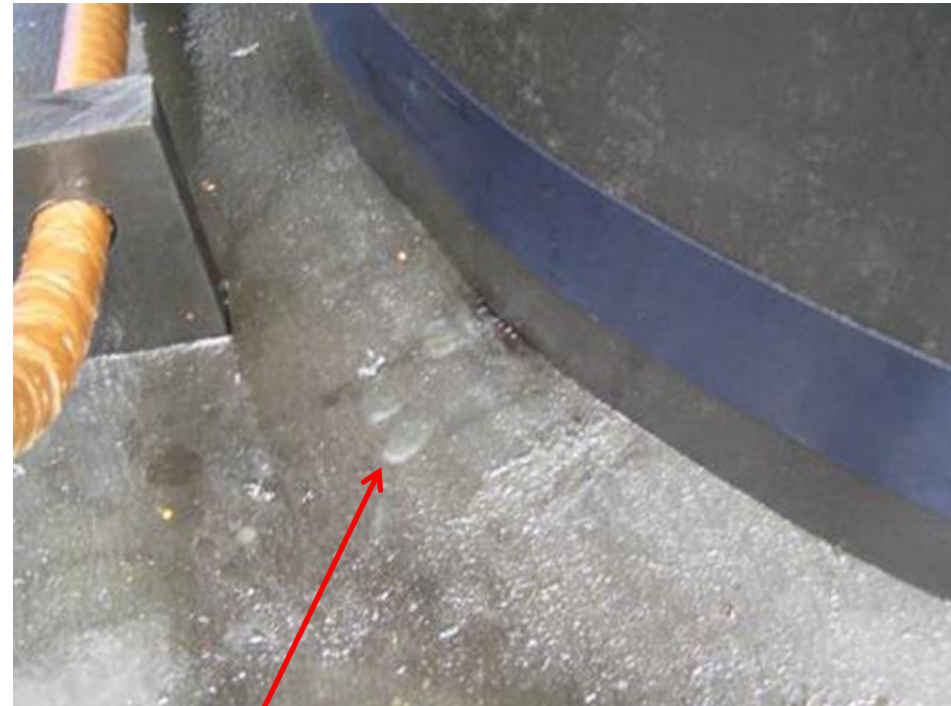
**Traces of Water**
