Induced Stray Voltages from Transmission Lines

Shashi Patel
Frank Lambert

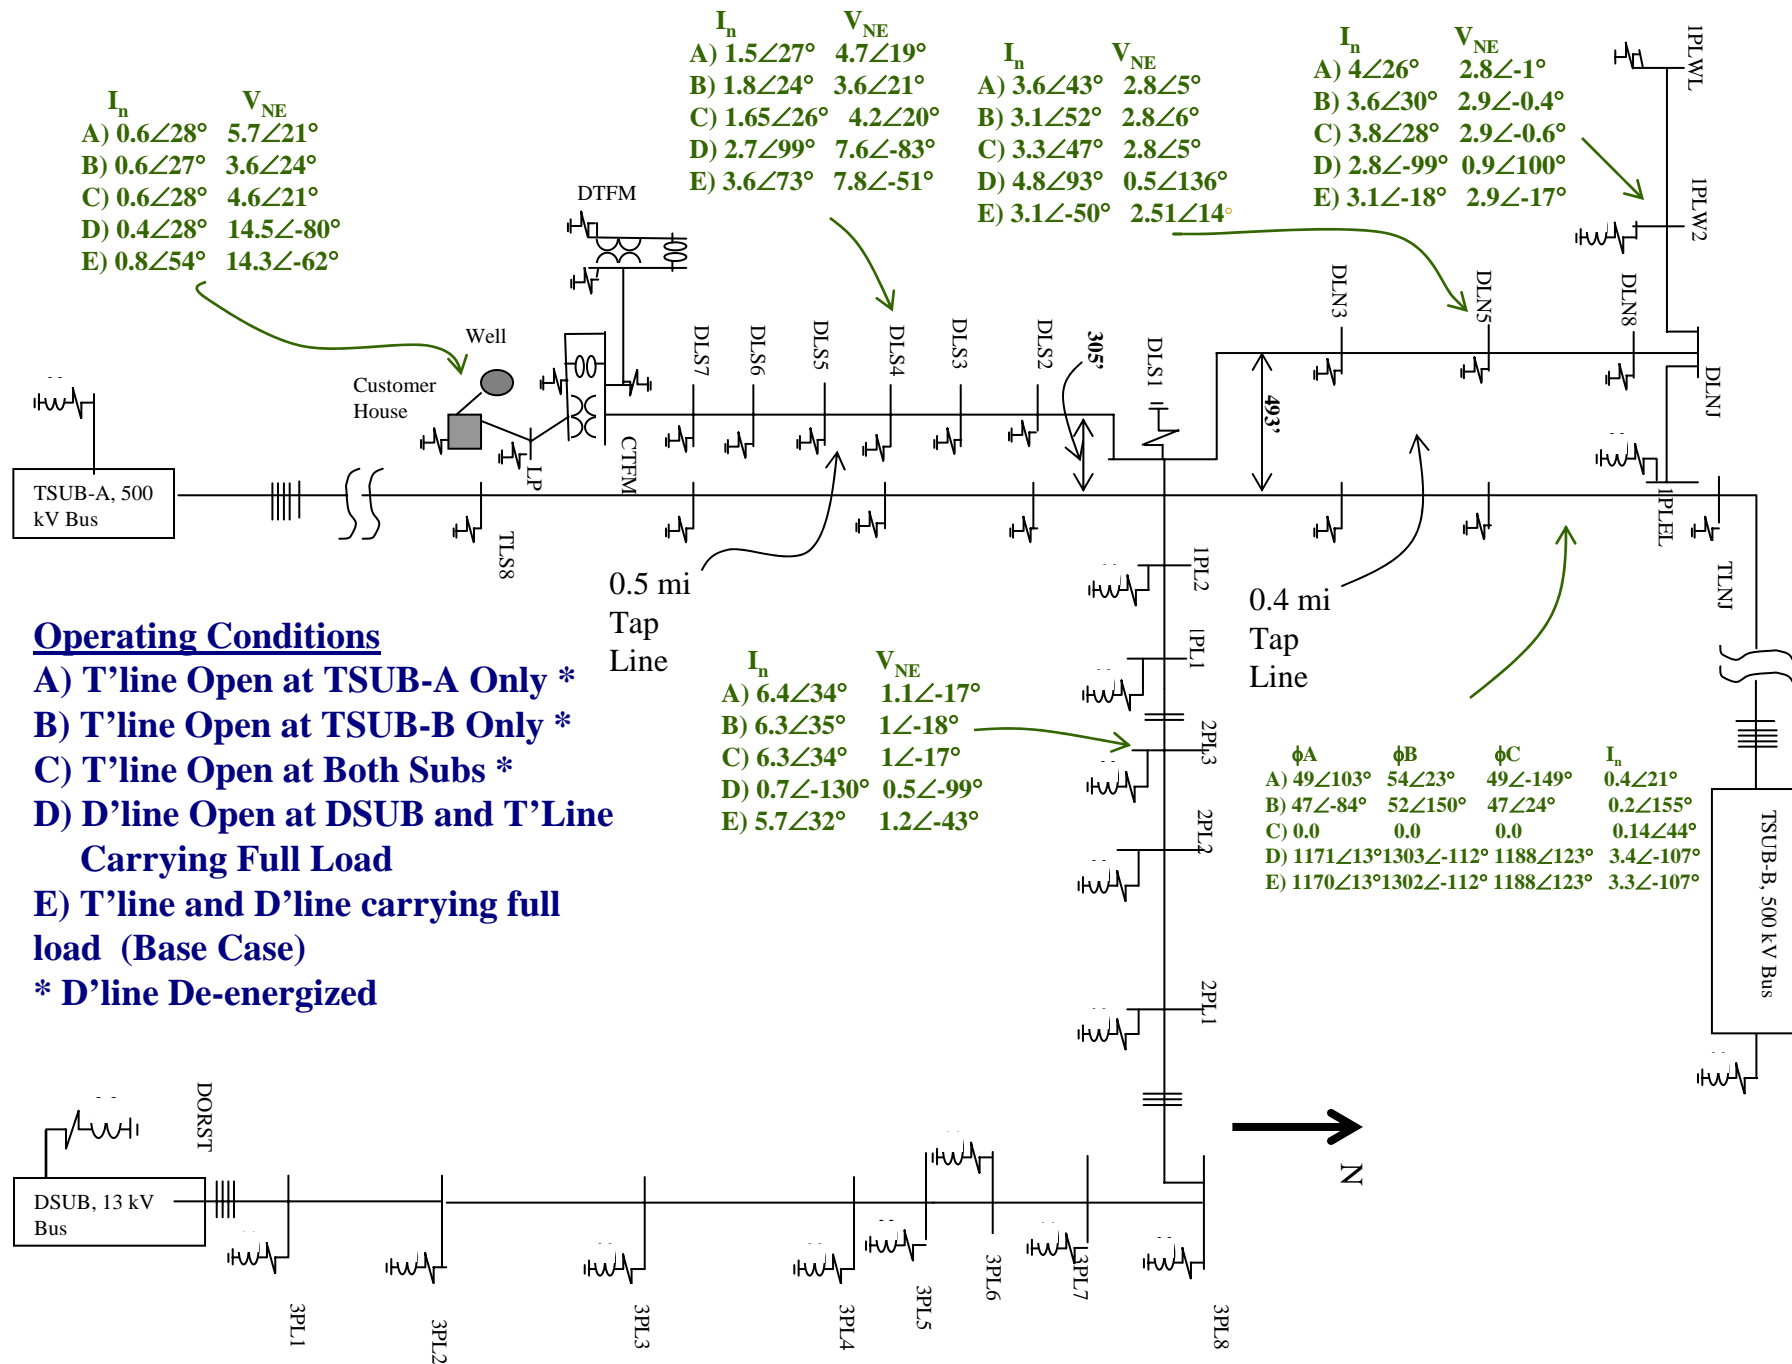
Operating Conditions

I_n	V_{NE}
A) $0.6 \angle 28^\circ$	$5.7 \angle 21^\circ$
B) $0.6 \angle 27^\circ$	$3.6 \angle 24^\circ$
C) $0.6 \angle 28^\circ$	$4.6 \angle 21^\circ$
D) $0.4 \angle 28^\circ$	$14.5 \angle -80^\circ$
E) $0.8 \angle 54^\circ$	$14.3 \angle -62^\circ$

I_n	V_{NE}
A) $1.5 \angle 27^\circ$	$4.7 \angle 19^\circ$
B) $1.8 \angle 24^\circ$	$3.6 \angle 21^\circ$
C) $1.65 \angle 26^\circ$	$4.2 \angle 20^\circ$
D) $2.7 \angle 99^\circ$	$7.6 \angle -83^\circ$
E) $3.6 \angle 73^\circ$	$7.8 \angle -51^\circ$

I_n	V_{NE}
A) $3.6 \angle 43^\circ$	$2.8 \angle 5^\circ$
B) $3.1 \angle 52^\circ$	$2.8 \angle 6^\circ$
C) $3.3 \angle 47^\circ$	$2.8 \angle 5^\circ$
D) $4.8 \angle 93^\circ$	$0.5 \angle 136^\circ$
E) $3.1 \angle -50^\circ$	$2.51 \angle 14^\circ$

I_n	V_{NE}
A) $4 \angle 26^\circ$	$2.8 \angle -1^\circ$
B) $3.6 \angle 30^\circ$	$2.9 \angle -0.4^\circ$
C) $3.8 \angle 28^\circ$	$2.9 \angle -0.6^\circ$
D) $2.8 \angle -99^\circ$	$0.9 \angle 100^\circ$
E) $3.1 \angle -18^\circ$	$2.9 \angle -17^\circ$

I_n	V_{NE}
A) $6.4 \angle 34^\circ$	$1.1 \angle -17^\circ$
B) $6.3 \angle 35^\circ$	$1 \angle -18^\circ$
C) $6.3 \angle 34^\circ$	$1 \angle -17^\circ$
D) $0.7 \angle -130^\circ$	$0.5 \angle -99^\circ$
E) $5.7 \angle 32^\circ$	$1.2 \angle -43^\circ$

ϕA	ϕB	ϕC	I_n
A) $49 \angle 103^\circ$	$54 \angle 23^\circ$	$49 \angle -149^\circ$	$0.4 \angle 21^\circ$
B) $47 \angle -84^\circ$	$52 \angle 150^\circ$	$47 \angle 24^\circ$	$0.2 \angle 155^\circ$
C) 0.0	0.0	0.0	$0.14 \angle 44^\circ$
D) $1171 \angle 13^\circ$	$1303 \angle -112^\circ$	$1188 \angle 123^\circ$	$3.4 \angle -107^\circ$
E) $1170 \angle 13^\circ$	$1302 \angle -112^\circ$	$1188 \angle 123^\circ$	$3.3 \angle -107^\circ$

- A) T'line Open at TSUB-A Only *
- B) T'line Open at TSUB-B Only *
- C) T'line Open at Both Subs *
- D) D'line Open at DSUB and T'Line
- Carrying Full Load
- E) T'line and D'line carrying full load (Base Case)
- * D'line De-energized

- **Modeled the subject feeder from the substation to the customer including the parallel transmission line.**
- **Validated the model by comparing the results with the measured data.**
- **Identified the sources by simulating various operating conditions.**

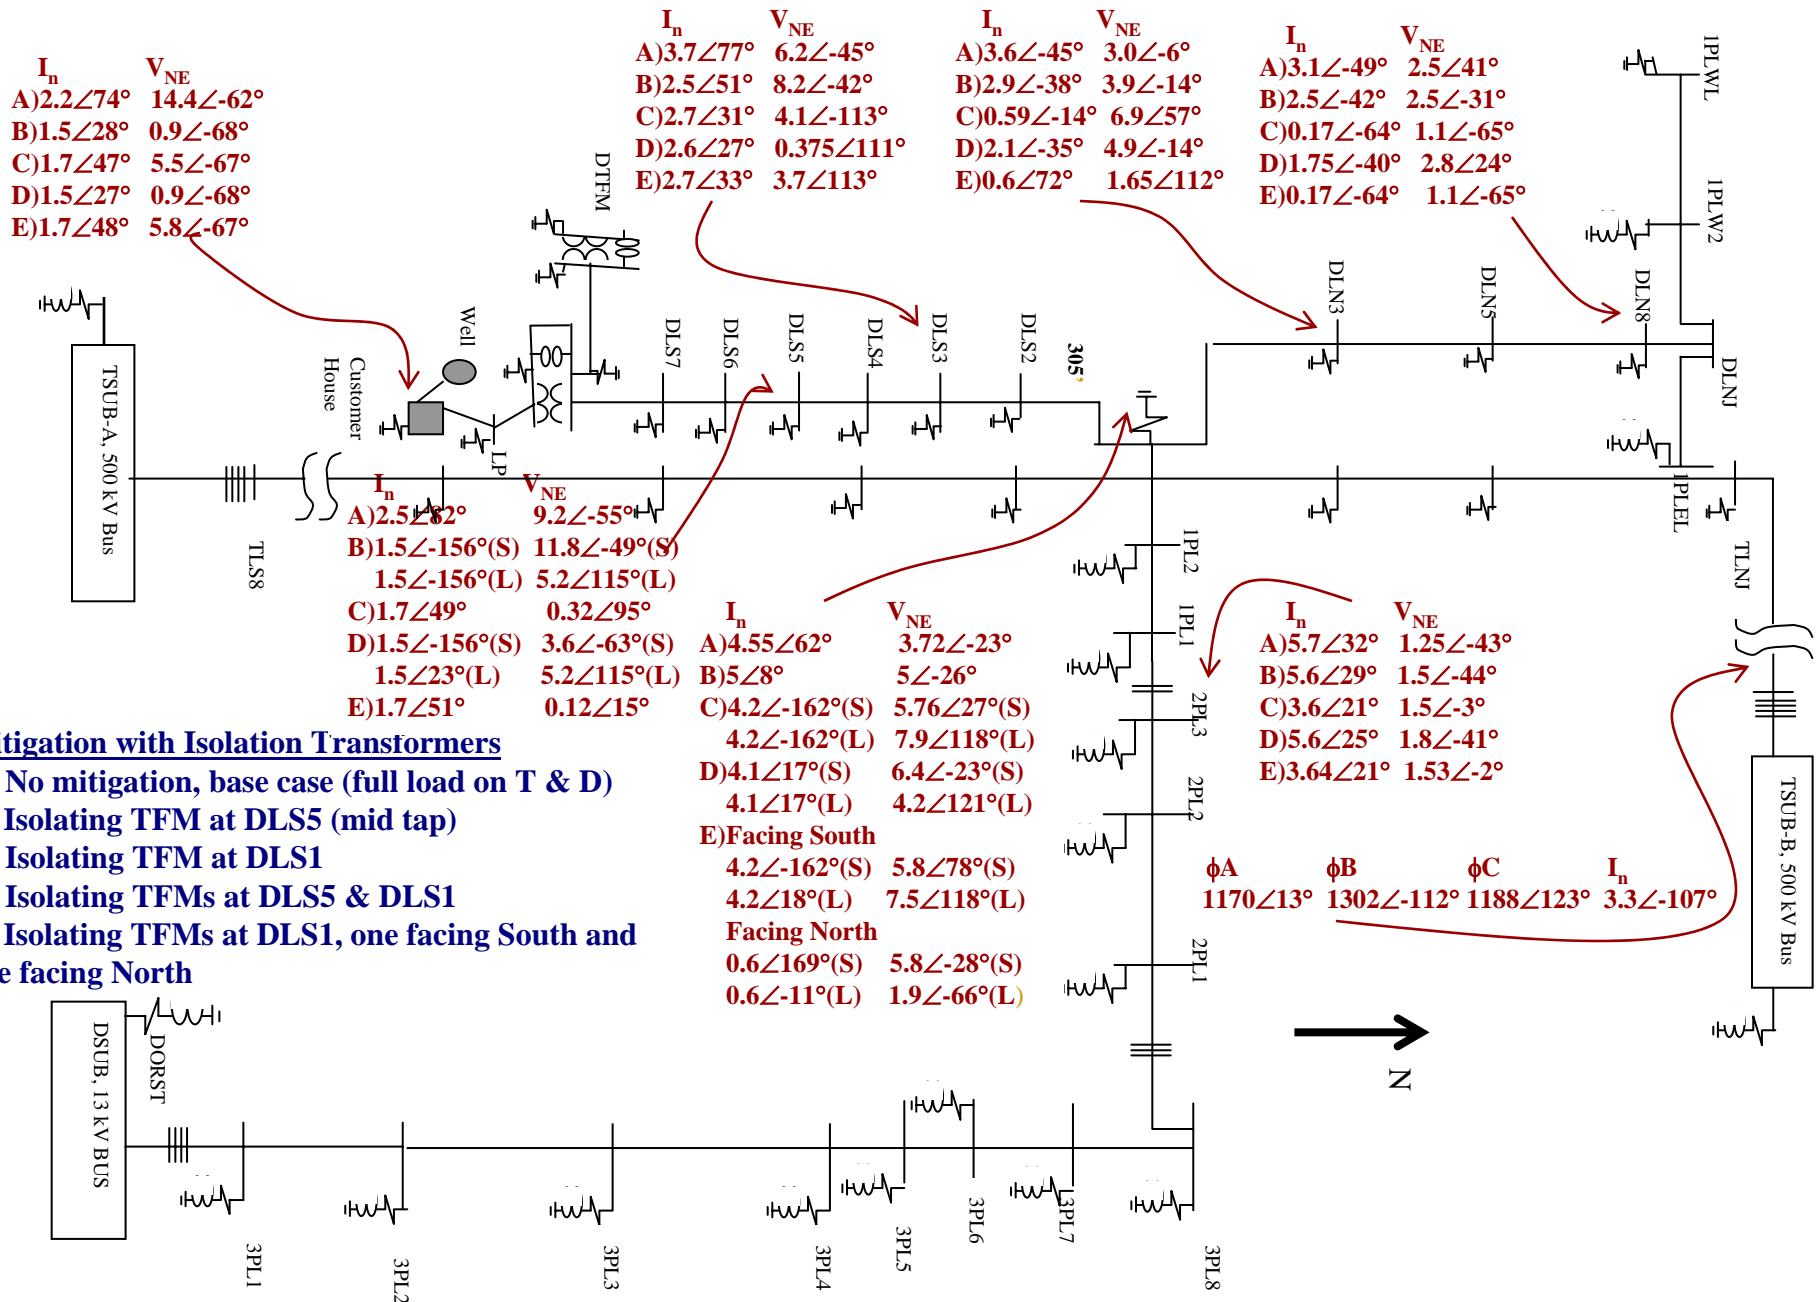
Mitigation with Isolation Transformers

I_n V_{NE}
 A) 2.2∠74° 14.4∠-62°
 B) 1.5∠28° 0.9∠-68°
 C) 1.7∠47° 5.5∠-67°
 D) 1.5∠27° 0.9∠-68°
 E) 1.7∠48° 5.8∠-67°

I_n V_{NE}
 A) 3.7∠77° 6.2∠-45°
 B) 2.5∠51° 8.2∠-42°
 C) 2.7∠31° 4.1∠-113°
 D) 2.6∠27° 0.375∠111°
 E) 2.7∠33° 3.7∠113°

I_n V_{NE}
 A) 3.6∠-45° 3.0∠-6°
 B) 2.9∠-38° 3.9∠-14°
 C) 0.59∠-14° 6.9∠57°
 D) 2.1∠-35° 4.9∠-14°
 E) 0.6∠72° 1.65∠112°

I_n V_{NE}
 A) 3.1∠-49° 2.5∠41°
 B) 2.5∠-42° 2.5∠-31°
 C) 0.17∠-64° 1.1∠-65°
 D) 1.75∠-40° 2.8∠24°
 E) 0.17∠-64° 1.1∠-65°

I_n V_{NE}
 A) 2.5∠82° 9.2∠-55°
 B) 1.5∠-156°(S) 11.8∠-49°(S)
 1.5∠-156°(L) 5.2∠115°(L)
 C) 1.7∠49° 0.32∠95°
 D) 1.5∠-156°(S) 3.6∠-63°(S)
 1.5∠23°(L) 5.2∠115°(L)
 E) 1.7∠51° 0.12∠15°

I_n V_{NE}
 A) 4.55∠62° 3.72∠-23°
 B) 5∠8° 5∠-26°
 C) 4.2∠-162°(S) 5.76∠27°(S)
 4.2∠-162°(L) 7.9∠118°(L)
 D) 4.1∠17°(S) 6.4∠-23°(S)
 4.1∠17°(L) 4.2∠121°(L)
 E) Facing South
 4.2∠-162°(S) 5.8∠78°(S)
 4.2∠18°(L) 7.5∠118°(L)
 Facing North
 0.6∠169°(S) 5.8∠-28°(S)
 0.6∠-11°(L) 1.9∠-66°(L)

I_n V_{NE}
 A) 5.7∠32° 1.25∠-43°
 B) 5.6∠29° 1.5∠-44°
 C) 3.6∠21° 1.5∠-3°
 D) 5.6∠25° 1.8∠-41°
 E) 3.64∠21° 1.53∠-2°

ϕ_A ϕ_B ϕ_C I_n
 1170∠13° 1302∠-112° 1188∠123° 3.3∠-107°

- A) No mitigation, base case (full load on T & D)
- B) Isolating TFM at DLS5 (mid tap)
- C) Isolating TFM at DLS1
- D) Isolating TFMs at DLS5 & DLS1
- E) Isolating TFMs at DLS1, one facing South and one facing North

- **Breaks the length of the parallel section**
- **Effective solution for the entire tap**
- **Cable TV or telephone shields across the isolation transformers must be isolated to increase mitigation effectiveness.**
- **Proper fuse coordination is required.**

- **Installation of one or more isolation transformers along the parallel section is an effective solution for the customers served by the tap.**
- **For effective mitigation, Cable TV and telephone shields must be isolated across the isolation transformers.**
