Detection and Mitigation of Stray Voltage in Underground Distribution Systems

ConEdison

Power Survey Company

June 25th 2007

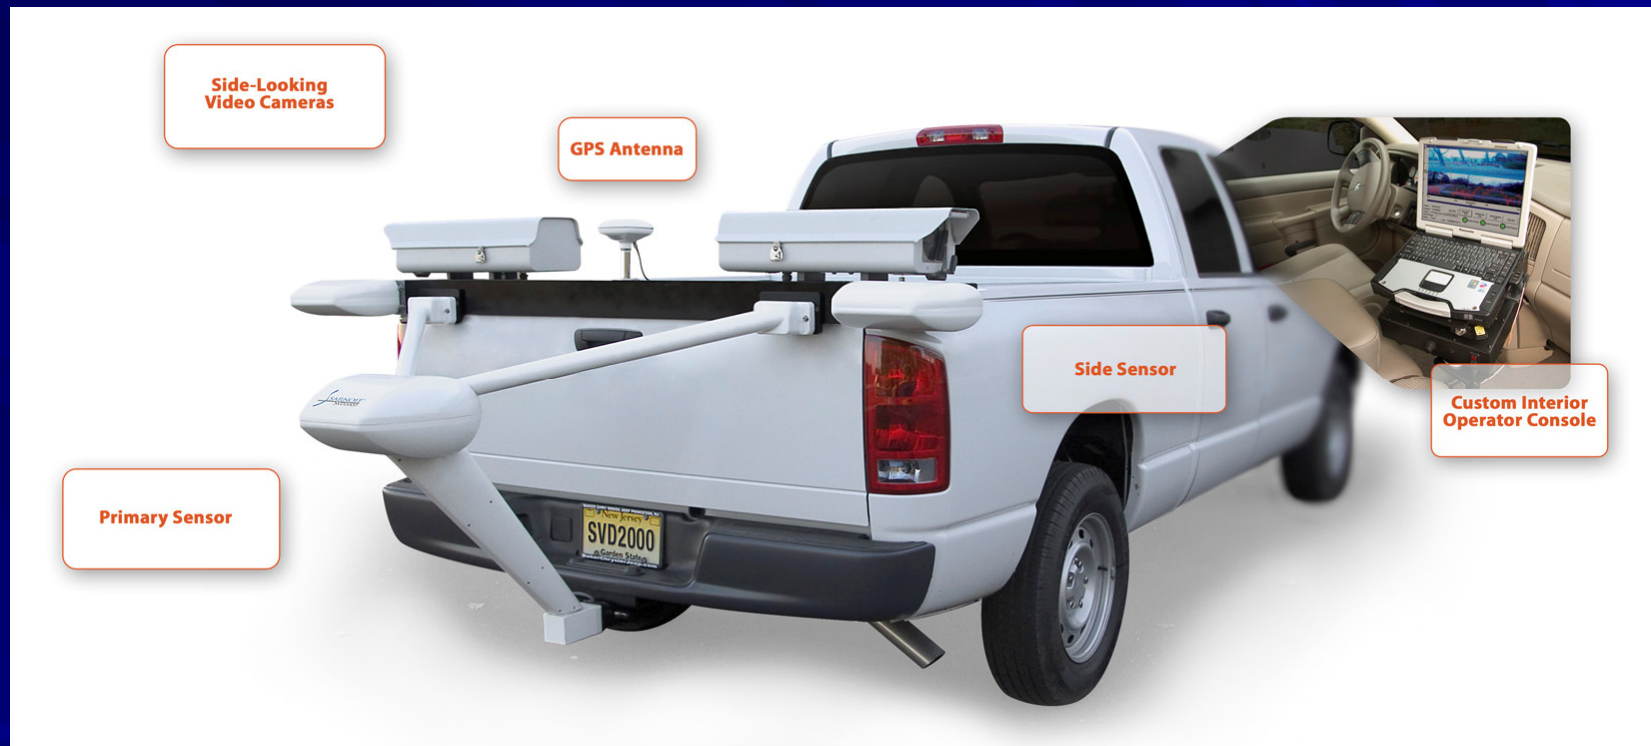
SVD2000 System

- Targeted at underground distribution area
- Secondary overhead distribution and temporary shunts do not preclude effective detection
- Operates at speeds up to 20 MPH
- Sophisticated signal processing allows only 60Hz
- Enabling technology for detection operations

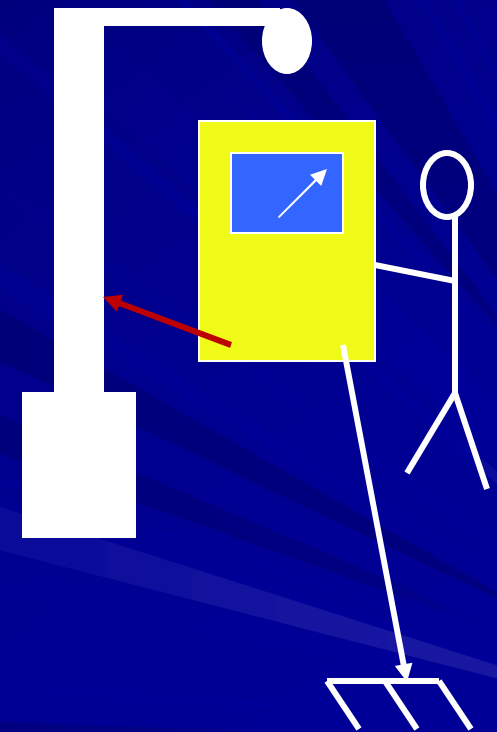
Troubleshooting Methods

- Strong E-field emanating from street lamp
- It's likely energized, let's measure the potential
- Use a voltmeter, make contact to the pole and find a good ground
- Be sure the selected ground is at low potential, check for E-field
- Measure with and without 500 Ω shunt (load resistor)
- Working group should address resistance value

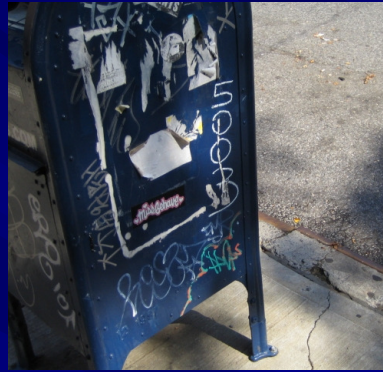
33V found on Brooklyn mailbox caused by burned service leg underground.

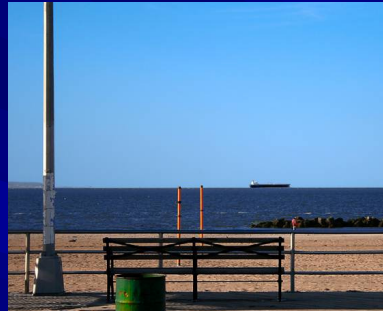
108V found on streetlight on beach. Repaired corroded neutral.

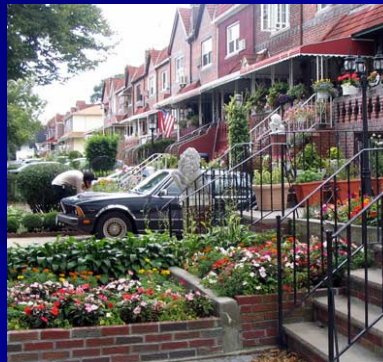
60V found on Foster Av sidewalk & front lawn. Service replaced.

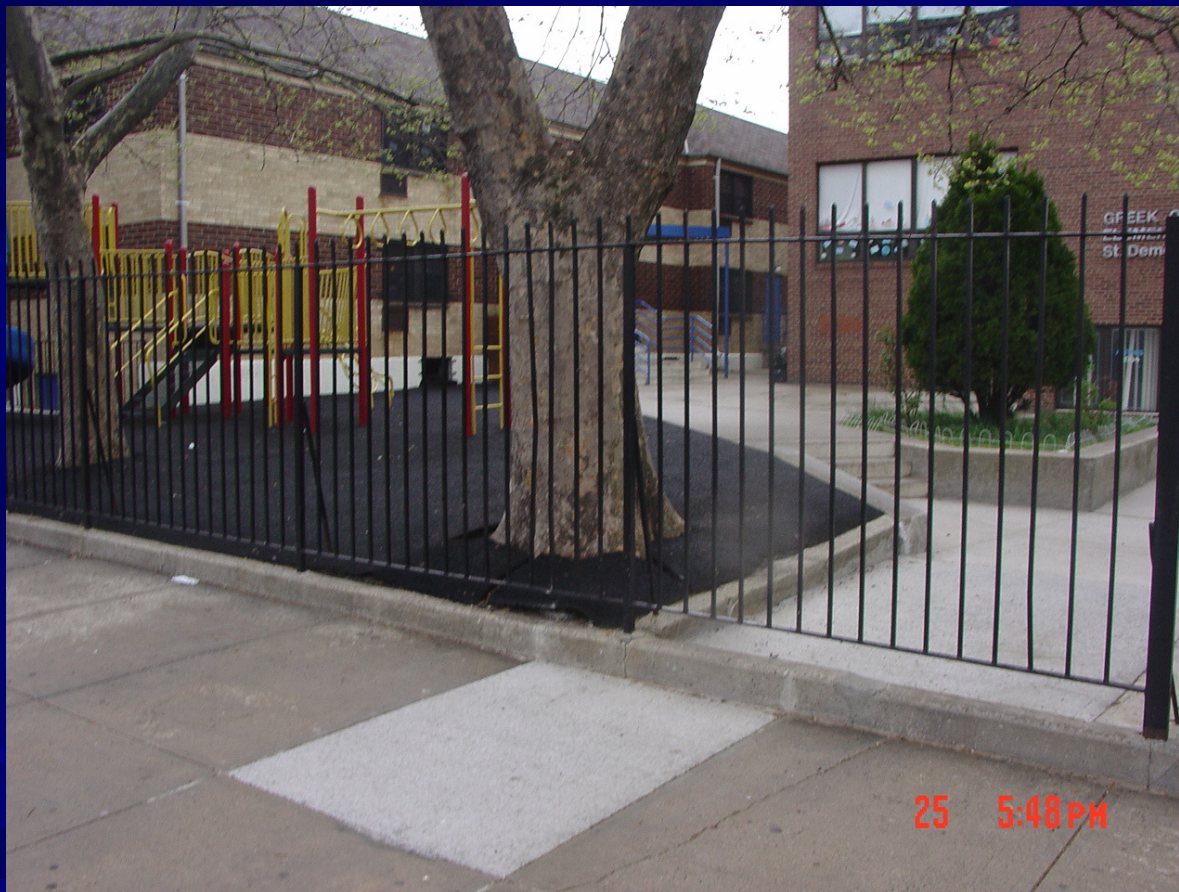
Case Study: St. Catherine's Church

112V on fence

**Service duct
cracked by tree
roots under
sidewalk**

**Detected by
mobile detector
and repaired**

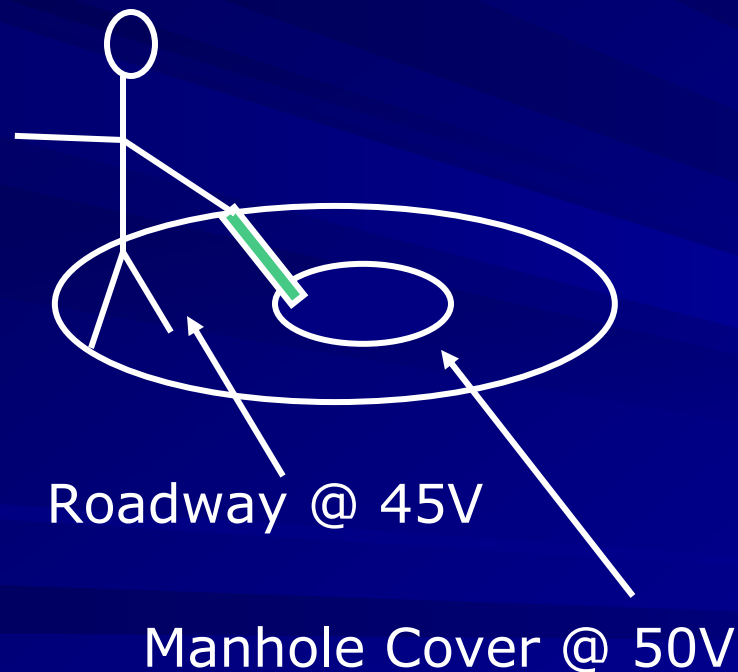
- Object was a recognized asset (manhole cover)
- Probe made good contact to cover
- Ground reference at high potential

Inspector may miss voltage

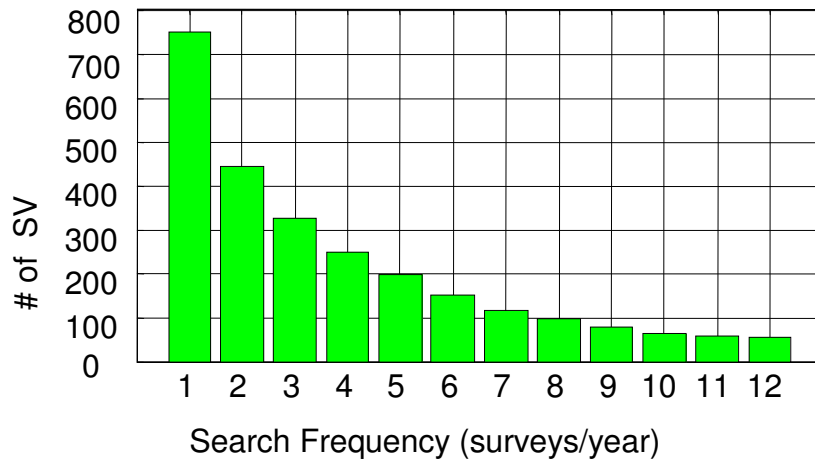
Predicted SV Exposure vs. # of Surveys

- New SV created over time
- Less than 100% detection each time

- Fewer SV found with each scan
- Fewer SV on system at all times
- Major reduction in shocks

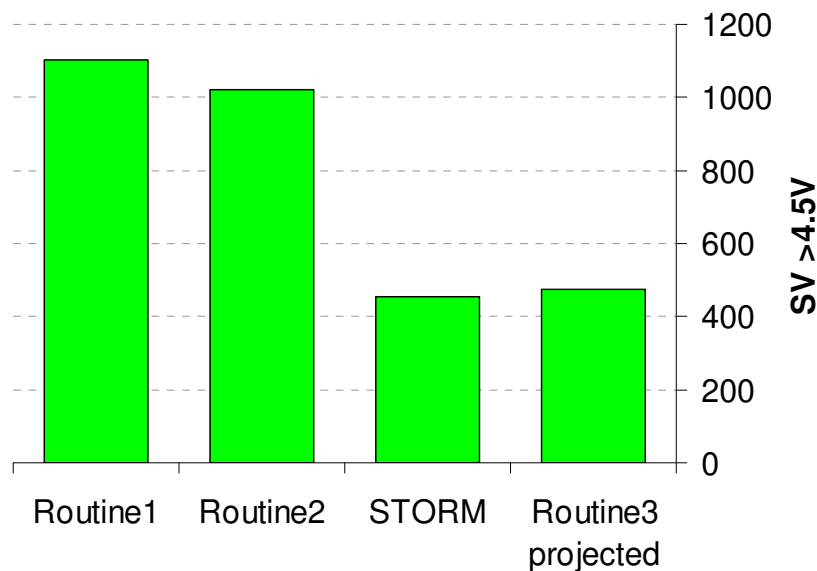
2006-2007 Mobile SV Detection Survey
Results

Finding less SV during successive scans

- Catching up with emergence rate
- Real measure of success is reduced shocks
