# Preliminary Drive Noise Measurements

David D. Brandt  
Rockwell Automation

- The purpose of this presentation is to:
  - Present “first pass” measurements of Drive noise induced in a communication cable typical of the 1000 m link segment
  - Consider whether a more extensive evaluation is warranted

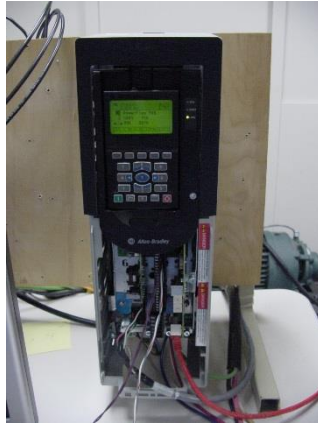
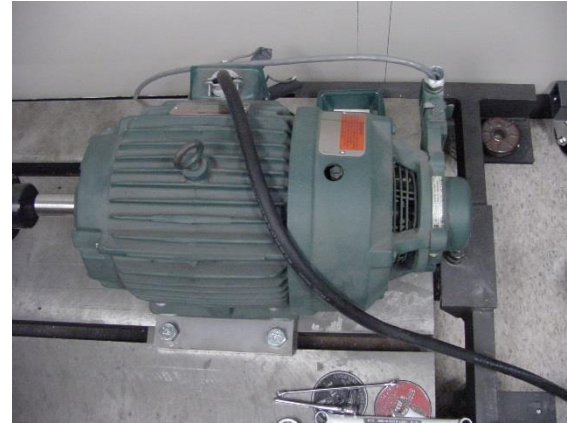
- Drive: PowerFlex 755, 7.5 hp
  - PWM configured to 12 kHz
- Motor: Reliance Electric Duty Master, 10 hp
  - No load
- Cable: Carol 4C 10 AWG
  - No Shield (systems below 10 hp are often unshielded)

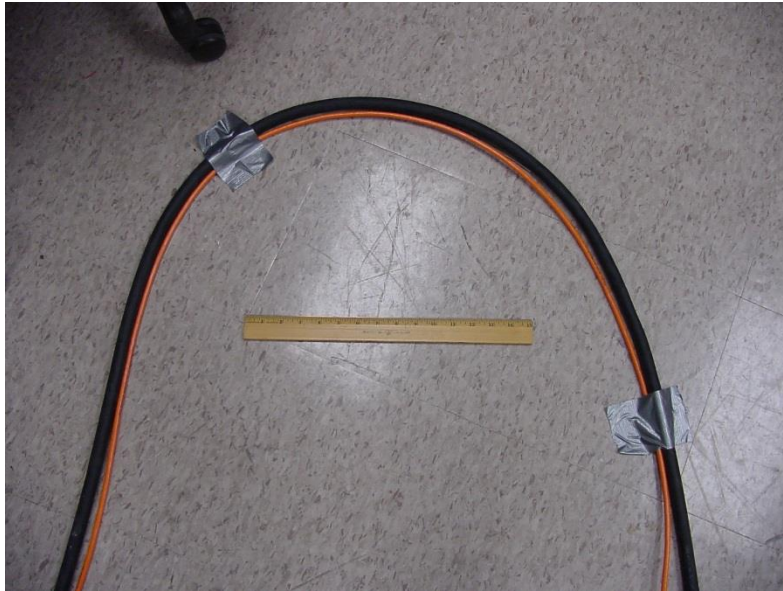
- The communication cable was placed in parallel to the motor control cable
- Two variations
  - Adjacent
  - Approximately 20 cm separation
