IEEE 802.3cg STP Noise Test Setup

High Quality STP Cable Type For Test

This is a follow-up to the May 10 Ad Hoc presentation

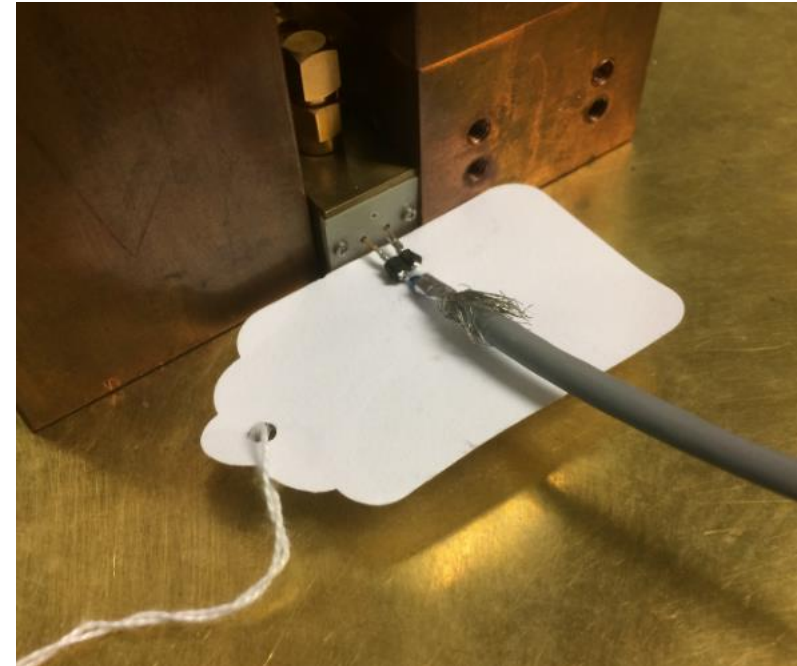
So here is an experiment:

Create a **bad shield connection** (capacitive isolated with paper dielectric)

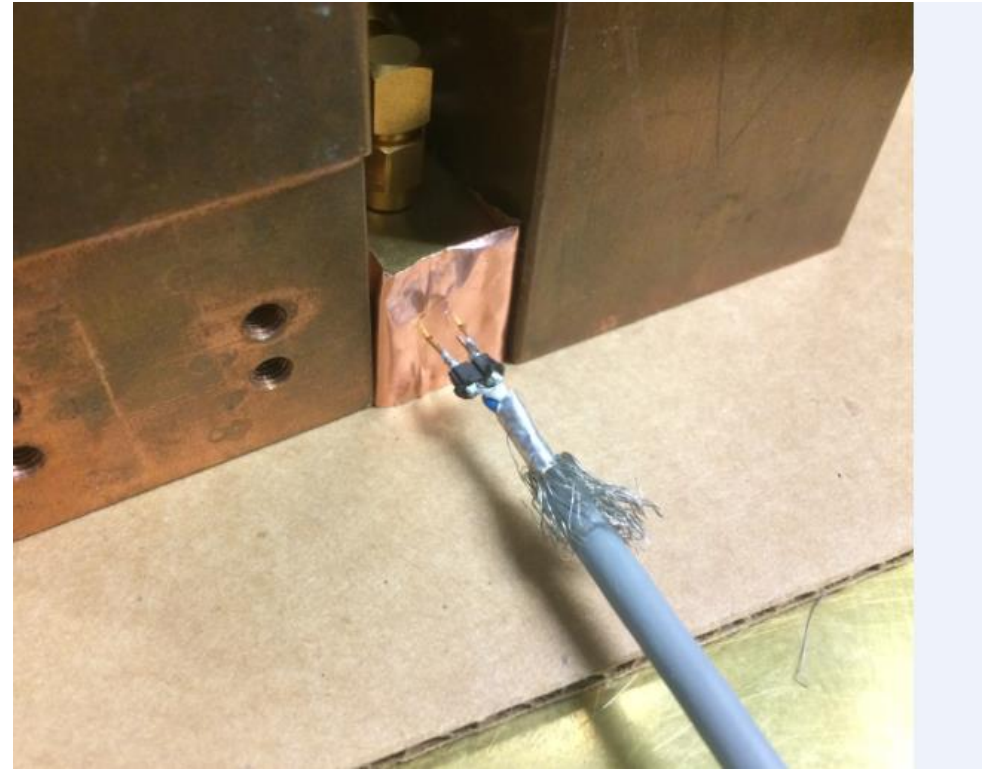
Check if the Scope and BALUN are actually working properly with a null experiment:

Ground out the two BALUN pins

The transients must go through the Scope ground

No impulses detected so the Scope grounding effectively handles the transient
