# ***Case Study:*** **Investigation into Transformer Failure and Positioning of On-Line Moisture Probes**

*Prof. Valery G. Davydov*  
*Consultant*  
*Melbourne, Australia*

**WG PC57.162 Moisture in Insulation Systems**  
F16 IEEE Transformers Committee Meeting  
24 Oct 2016  
Vancouver, BC Canada

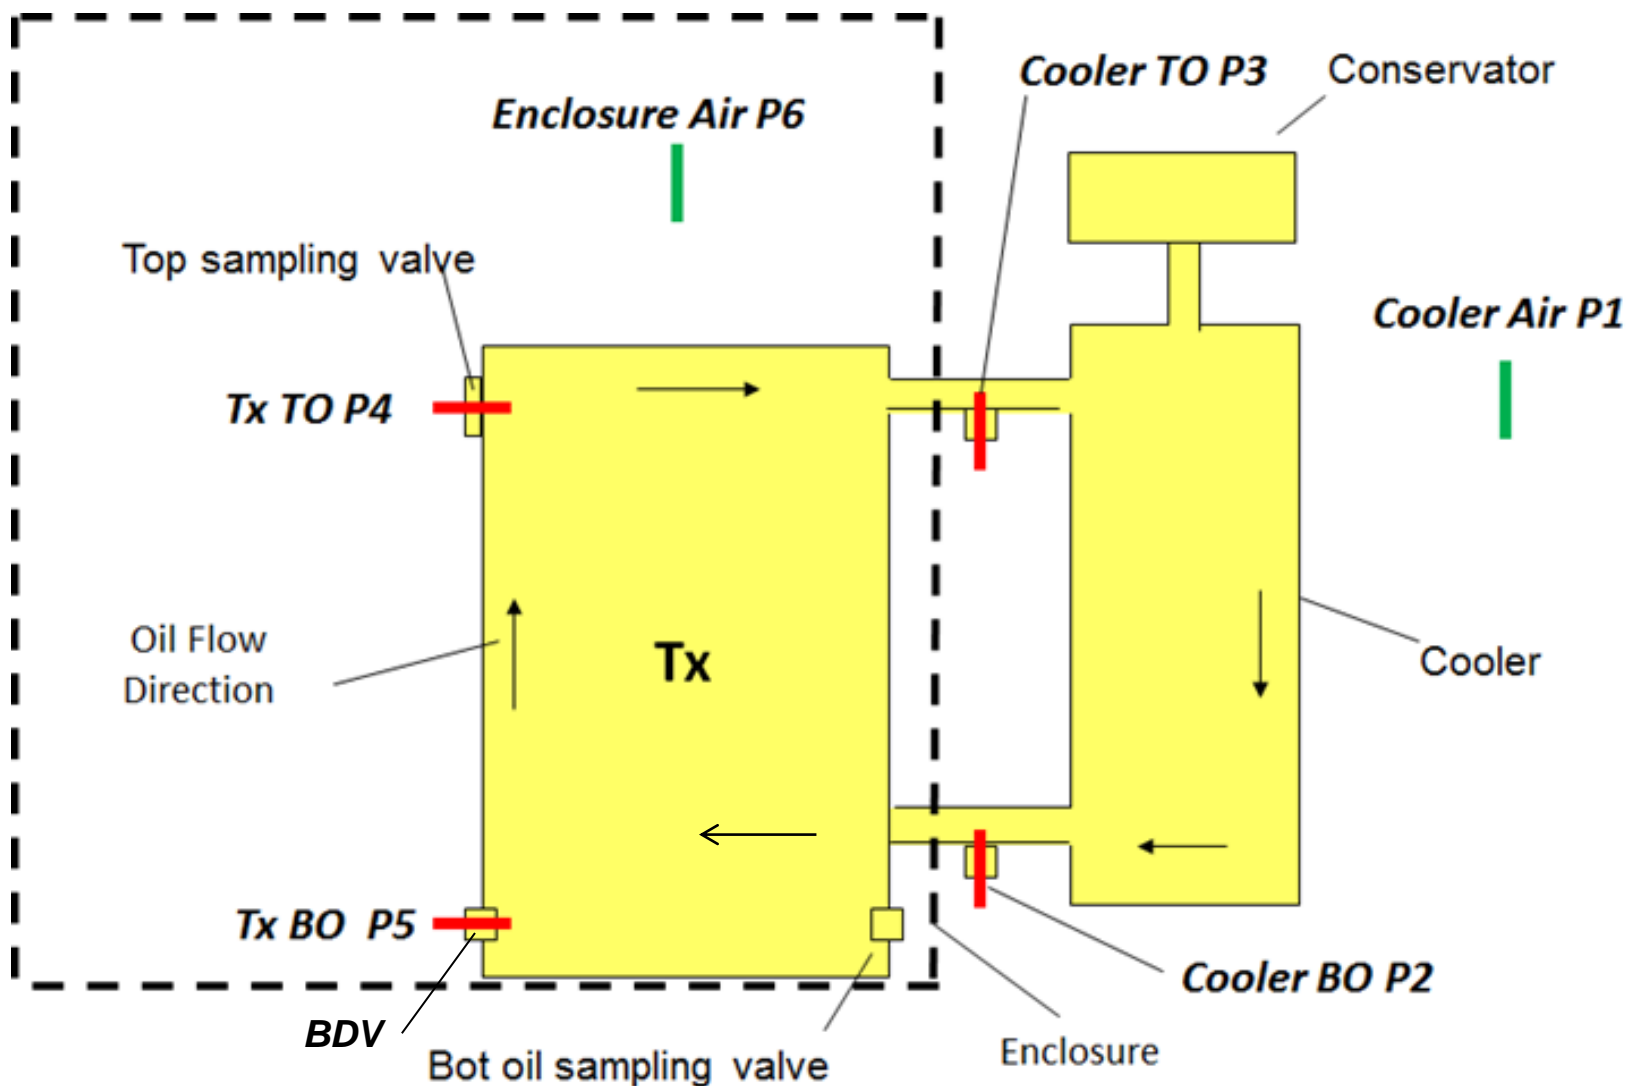
# Location of Moisture Probes (2007 - Present)

**Legend:** *P* – Probe, *TO* – Top Oil, *BO* – Bottom Oil

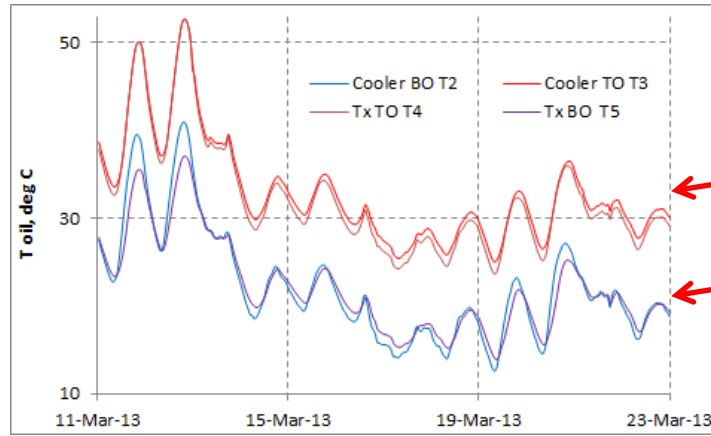
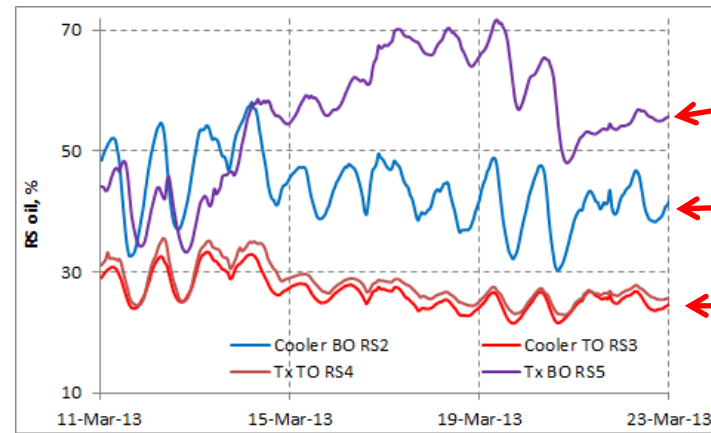
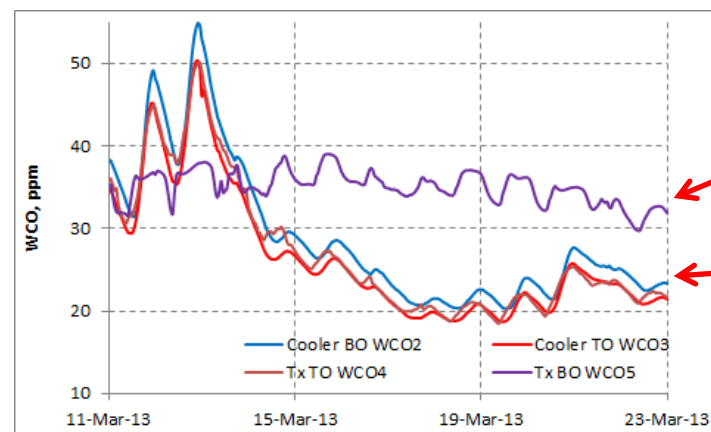
# E.g: Oil Temp, RS & WCO for 11-23 Mar 2013

$T_{TO}$ , two top probes

$T_{BO}$ , two bot probes

RS, bot trf (P5)

RS, bot cooler (P2)

RS, two top probes

WCO, P5

WCO, two top & P2

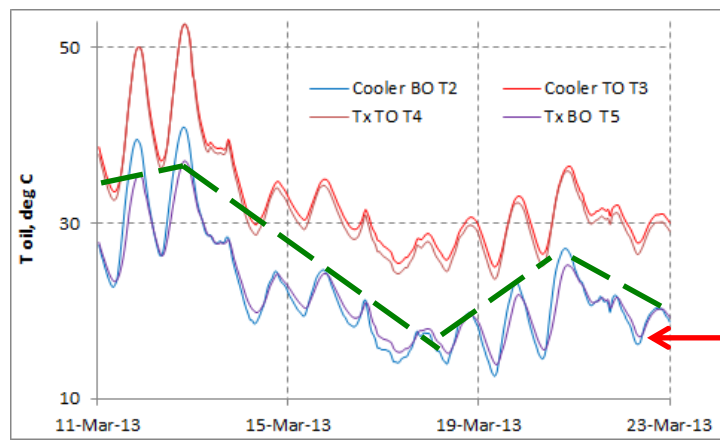
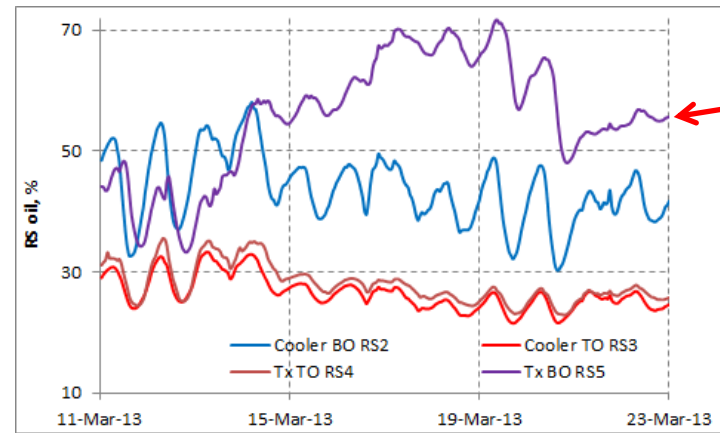
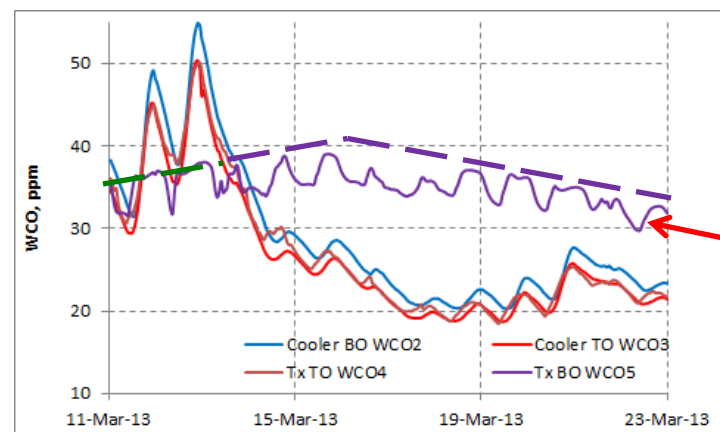
# Probe P5: Oil T, RS & WCO for 11-23 Mar 2013

$T_{BO}, P5$

$RS_{BO}, P5$

$WCO_{BO}, P5$

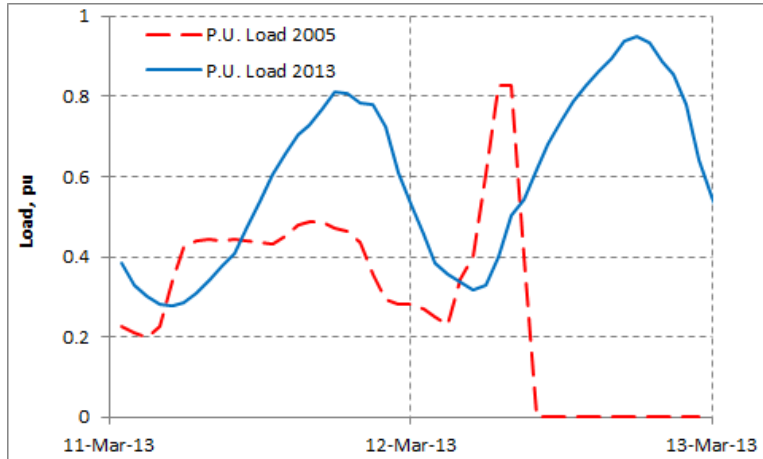
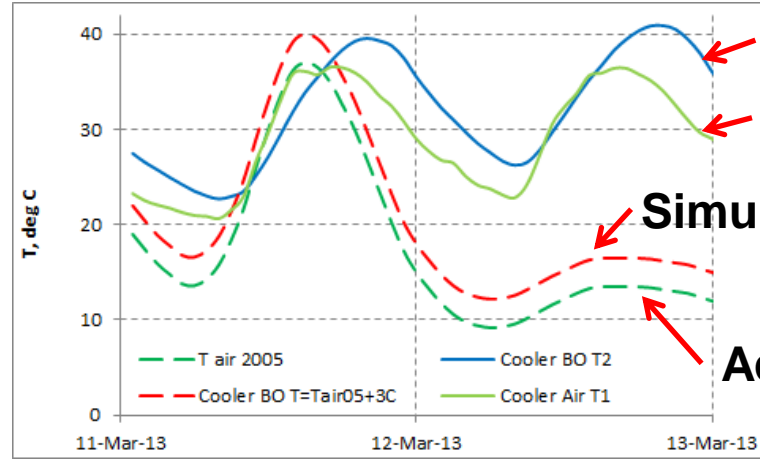
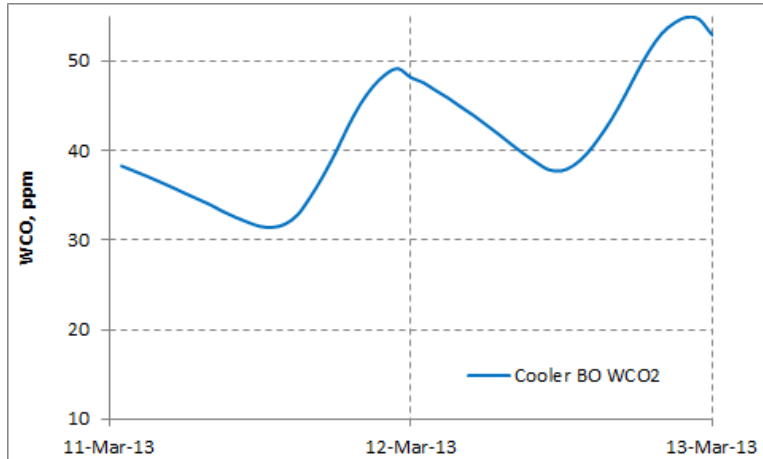
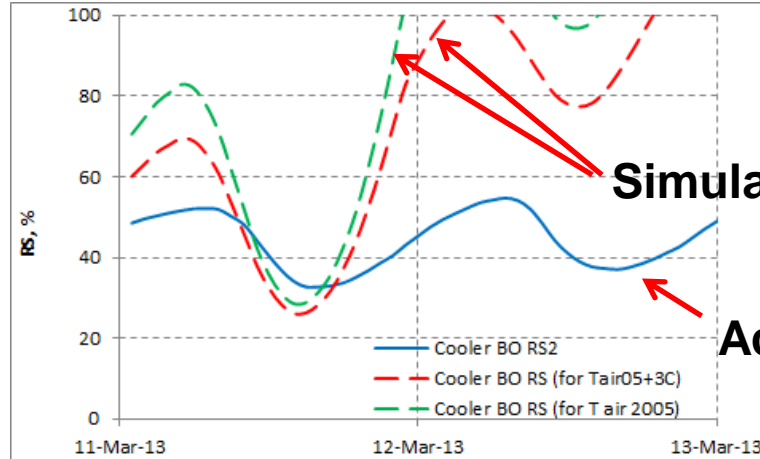
# Actual and Simulated Data

Actual  $T_{oil}$  2013

Actual  $T_{air}$  2013

Simulated  $T_{oil}$  2005

Actual  $T_{air}$  2005

Simulated  $RS_{2005}$

Actual  $RS_{2013}$
