***Thermal Effects of PoE
Phantom Current
on Magnetics***

Pulse Inc, Datacom Division

IEEE 802.3 March Plenary, 3/14/05

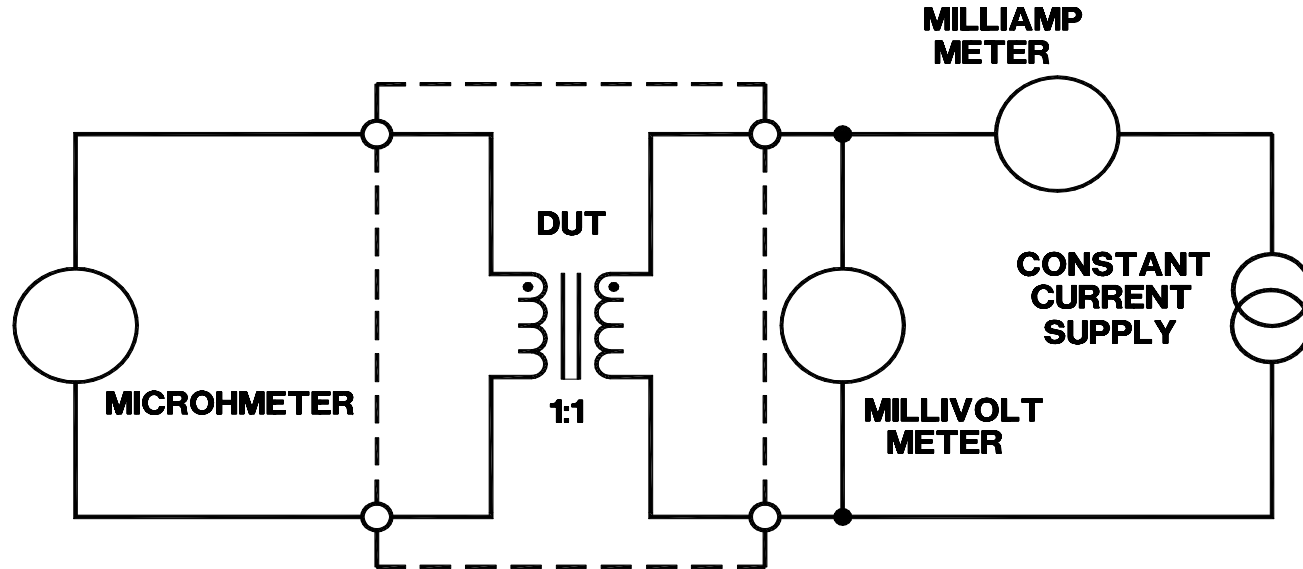
Test Setup

1. TEMPERATURE COEFFICIENT OF RESISTANCE IN COPPER WIRE

$$\text{RESISTANCE (R)} = R_{20} \bullet (1.00393) \bullet (T - 20))$$

WHERE: T = TEMPERATURE IN °C

R₂₀ = RESISTANCE AT 20 °C

2. CAVITY DIMENSIONS = .500W x .485L x .225H
3. DUT = 1 to 4 TRANSFORMERS
