# CAUI-4 Chip to Chip Burst Errors

**IEEE P802.3bm**

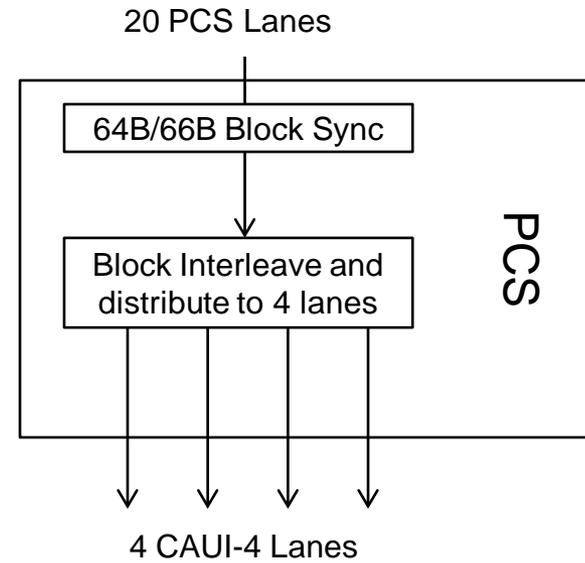
# Data Flow - TX

- You find block sync on all 20 PCS lanes
- Then perform block interleaving and distribute to 4 CAUI-4 lanes
- No need to fully de-skew or reorder lanes

- A simple fix is to block multiplex, why does this solve the issue?
  - With block multiplexing, a single burst error impacts up to two PCS lanes only and creates up to two burst errors

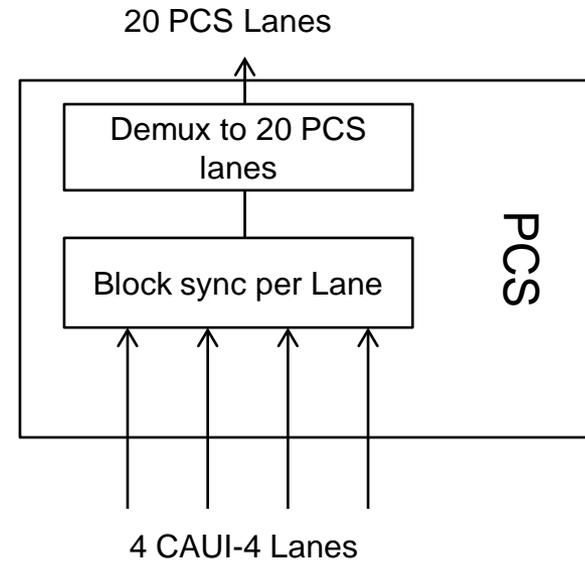
# Data Flow - RX

- You find block sync on all 4 CAUI-4 lanes
- Then distribute to 20 PCS lanes
- No need to fully de-skew or reorder PCS lanes
